Subject: Investigating Committee's Report of the Solid State
Physics Contamination Incident

Report
of
Investigating Committee

BUILDING 3025 INCIDENT
Oak Ridge National Laboratory
April 26, 1960

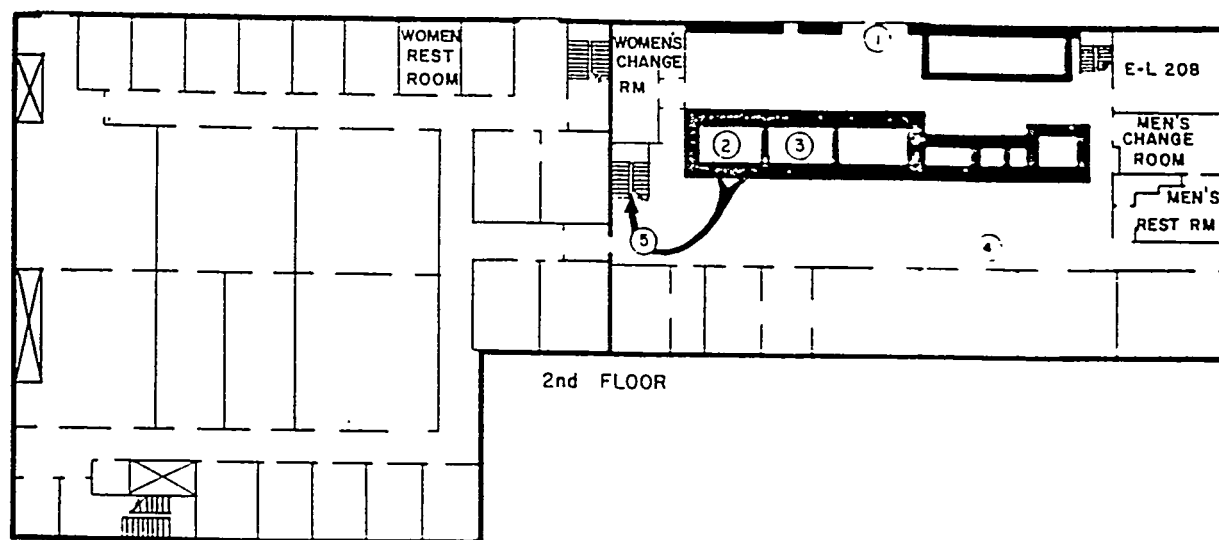
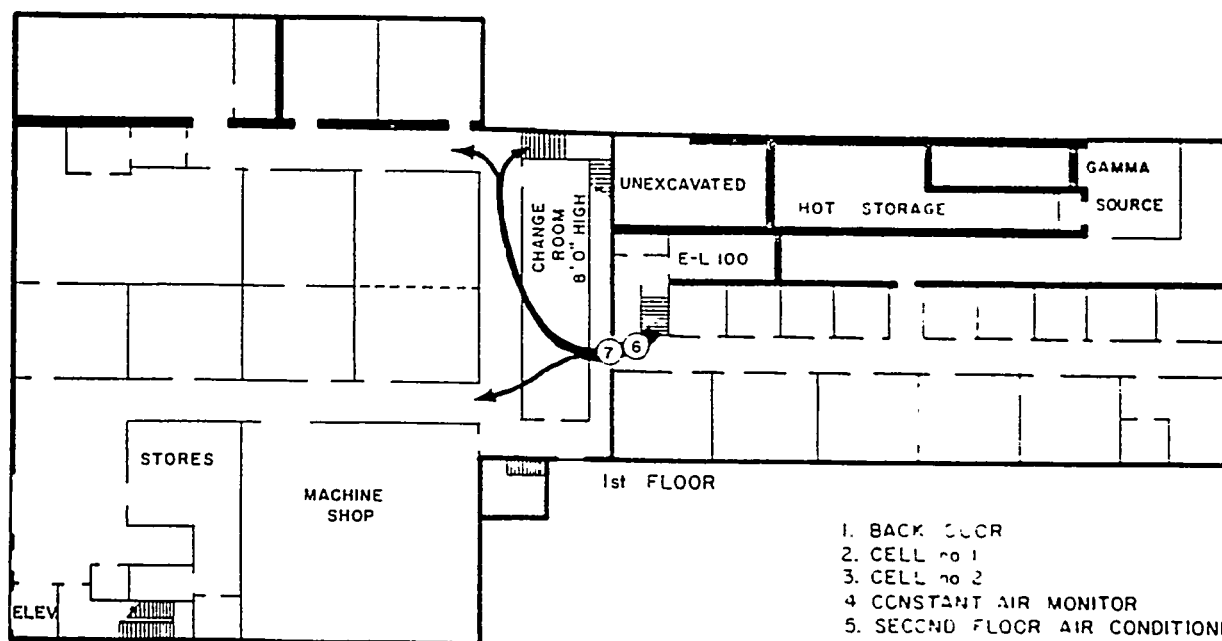
FIG. 1 BUILDING 3025 FLOOR PLAN

A floor plan of Building 3025 is given in Fig. 1. The main radioactive dust cloud after leaving the face of Cell 1 was sucked down the stairwell just west of the cell. A large fraction of the cloud was picked up by the air conditioners at the head and foot of these stairs. Most of this activity was caught on the intake filters for these air conditioners. The remainder was then distributed back over the hot cell area. The filters on these air conditioners read 3-4 r/hr after the incident.

1. BACK DOOR
2. CELL no 1
3. CELL no 2
4. CONSTANT AIR MONITOR
5. SECOND FLOOR AIR CONDITIONER
6. FIRST FLOOR AIR CONDITIONER
7. CONNECTING DOOR,
(PROPPED OPEN AT TIME OF INCIDENT)

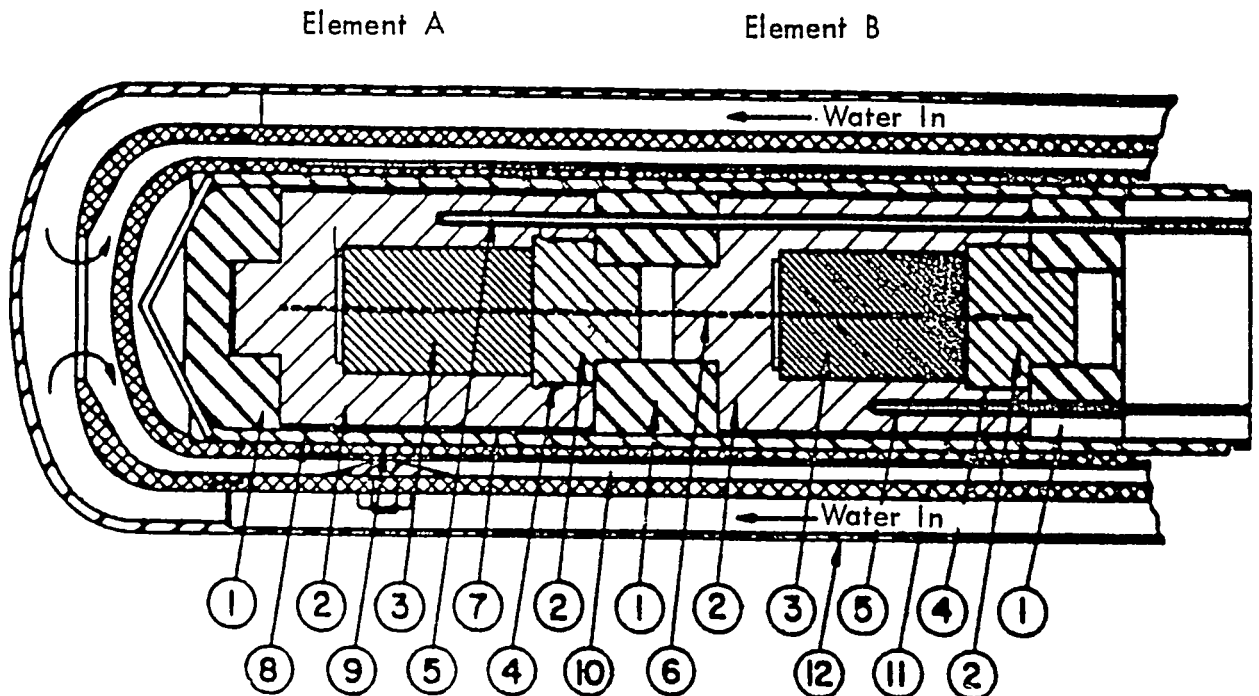
Fig. 2. Diagram of assembly for ORNL-MTR-48 in-pile capsule irradiation test.

Figure 2 is an assembly diagram of the fuel-containing section of the experiment, and Fig. 3 is a diagram of element B, the one which was cut open, showing the positions of the saw cuts.

Examination of this experiment was begun by making a saw cut through the outer containment vessel, item 9, Fig. 2. The mixture of helium fill gas and the fission gases evolved from the fuel was collected by piercing a tube attached to the inner containment vessel, item 8, Fig. 2. Another saw cut through both containment vessels allowed removal of the two fuel capsules, elements A and B. The external dimensions of these graphite containers were measured with micrometers. The fuel cylinder was removed from element B by making saw cuts as indicated. It should be pointed out that the fuel cylinder definitely was not cut, since (1) the small shoulder of the graphite container was left intact at one end, and (2) a thin disk
